DEPARTMENT OF TRANSPORTATION**DIVISION OF ENGINEERING SERVICES**

Quality Assurance and Source Inspection

Contract #: 04-0120F4Cty: SF/ALA Rte: 80 PM: 13.2/13.9File #: 1.28**WELDING INSPECTION REPORT****Resident Engineer:** Siegenthaler, Peter**Address:** 333 Burma Road**City:** Oakland, CA 94607**Report No:** WIR-017902**Date Inspected:** 04-Nov-2010**Project Name:** SAS Superstructure**OSM Arrival Time:** 1000**Prime Contractor:** American Bridge/Fluor Enterprises, a JV**OSM Departure Time:** 1830**Contractor:** American Bridge/Fluor Enterprises, a JV**Location:** Jobsite**CWI Name:** See below**CWI Present:** Yes No**Inspected CWI report:** Yes No N/A**Rod Oven in Use:** Yes No N/A**Electrode to specification:** Yes No N/A**Weld Procedures Followed:** Yes No N/A**Qualified Welders:** Yes No N/A**Verified Joint Fit-up:** Yes No N/A**Approved Drawings:** Yes No N/A**Approved WPS:** Yes No N/A**Delayed / Cancelled:** Yes No N/A**Bridge No:** 34-0006**Component:** SAS OBG**Summary of Items Observed:**

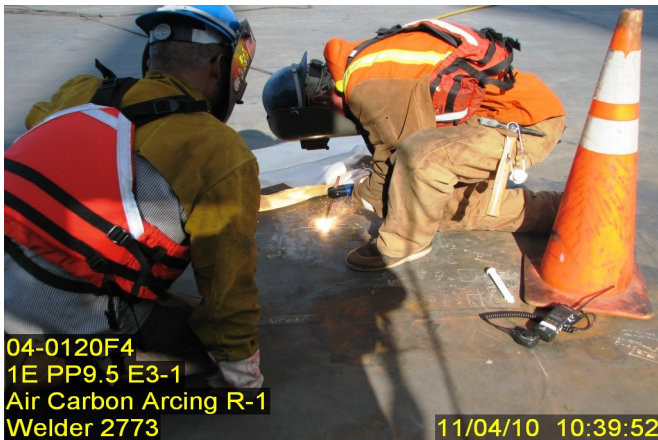
Exterior: OBG 1E-PP9.5-E3-weld 1

The QAI periodically observed AB/F approved welder Rick Clayborn (ID 2773) performing air carbon arc gouging to excavate one UT rejectable indication from the exterior surface of OBG 1E-PP9.5-E3-weld 1. See photo below.

The QAI periodically observed repair welding in the A deck at PP9.5 of the Lifting Rod Access Penetration Welds. Repair welding was per the Shielded Metal Arc Welding (SMAW) process in the 1G (flat) position. The QAI observed AB/F approved welder Darcell Jackson (ID 9967) performing welding of one excavated areas at PP9.5 weld E3-1. QC Inspector Patrick Swain was periodically present to monitor the progress and verify that the welding parameters were within the limits established by the approved welding Procedure Specification (WPS) identified as ABF-WPS-D1.5-1000 Repair rev. 2. The QAI observed QC Inspector Patrick Swain performing Magnetic Particle Testing (MT) of the excavation area prior to repair welding at this location. The QAI observed that the performance and evaluation of the MT appeared to comply with the MT procedure identified as SE-MT-CT-D1.5-101 Rev. 4. Welding was completed from the exterior at E3-1 and the QAI observed that the work appeared to be in general compliance with contract documents.

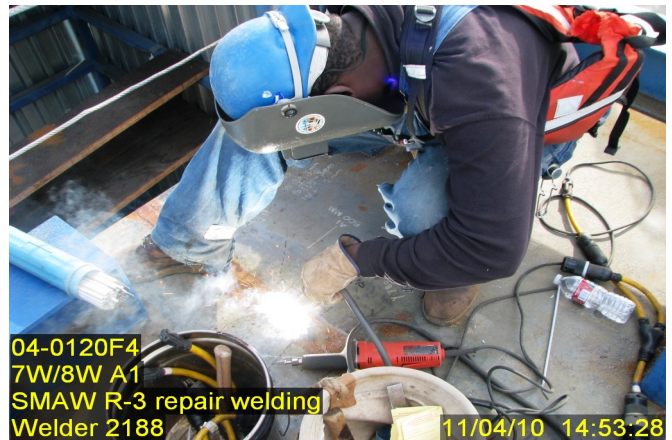
4). OBG Field Splice 7E/8E Weld ID: A1 & A2, Face A – (SMAW R-3 Repairs)

The QAI periodically observed AB/F approved welder Fred Kaddu (ID 2188) performing grinding to excavate R-3 Ultrasonic Testing (UT) repair locations and subsequently performing welding per the Shielded Metal Arc Welding (SMAW) process in the 1G (flat) position of OBG Field Splice 7E/8E Weld ID: A1 & A2. See photo below. QC Inspector Steve McConnell was present to monitor the progress and verify that the welding parameters were within the limits established by the approved welding Procedure Specification (WPS) identified as ABF-WPS-D1.5-1000 Repair. Mr. McConnell also performed Magnetic Particle Testing (MT) of the excavated areas prior to the repair welding. The QAI observed that the performance and evaluation of the MT appeared to comply with the MT procedure identified as SE-MT-CT-D1.5-101 Rev. 4. The QAI observed that Mr. Kaddu completed welding of (2) two excavations with the following dimensions at the following Y locations: Weld A1 - Y = 565mm, Length = 115mm, Depth = 20mm and Width = 30mm and Weld A2 - Y = 4775mm, Length = 125mm, Depth = 14mm and Width = 30mm. The QAI observed that work at these locations appeared to be in general compliance with contract documents. The QAI also observed a repair excavation (R-2) located at A5 – Y = 4595mm, Length = 230mm and Depth = 20mm and Width = 24mm. This area was excavated on 10-28-10 and the excavation is through-wall alongside the backing bar for a portion of the excavation length.
